The LEA+DRS Program

BICYCLING SAFETY 3: BLIND INTERSECTIONS AND PARKING LOT ENTRANCES / EXITS

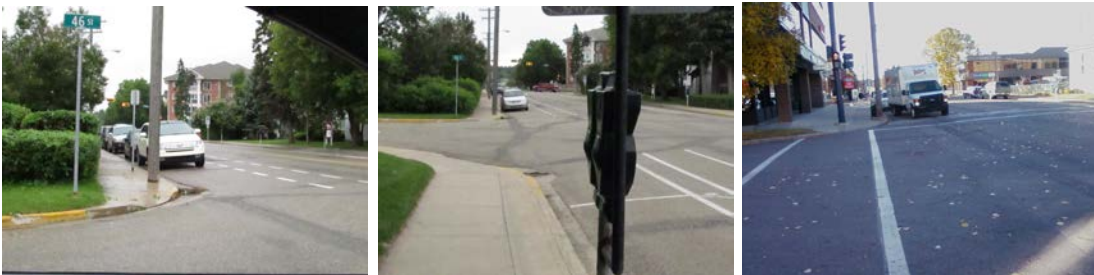
The photo below on the left shows the impaired view of oncoming traffic to the left for a driver waiting at the westbound stop sign of 46 Street and 49 Avenue. The middle photo gives a sense of how far forward a waiting driver must move to adequately see oncoming traffic from the left. And if a delivery truck is parked at the upstream end of the block, the problem can be much worse.

The issue occurs during weekday business hours, and during Saturday mornings and afternoons when the Public Market is operating. The problem is that vehicles parked in the parallel parking slots at the end of the block on either side of 48 Avenue seriously interfere with the ability of drivers, who are waiting at the cross street stop signs, to see oncoming traffic from their left. For many drivers, to see whether it is safe to move forward from the stop sign area, they must inch their vehicle so far forward that it will be in the 48 Avenue travel lanes.

- Vehicle drivers could use only the signalized intersections at 45 Street and 48 Street to enter or cross 48 Avenue. This would minimize the opportunity for at-fault collisions with bicyclists or vehicles approaching from the left.
- Bicyclists could be advised of the potential hazard at the stop sign intersections and parking lot exits so that they approach those danger points with appropriate caution.
- The City of Red Deer could eliminate sufficient upstream parking spots so that drivers wanting to enter or cross 48 Avenue from stop sign intersections or parking lots could have an adequate view of oncoming bicycles or vehicles.
